Direct Forklift and Equipment

TZ5696

Type of Equipment	Rail Car Mover
Make	Trackmobile

Model	5TMD	Year	
Serial Number	5696	Hours	1538

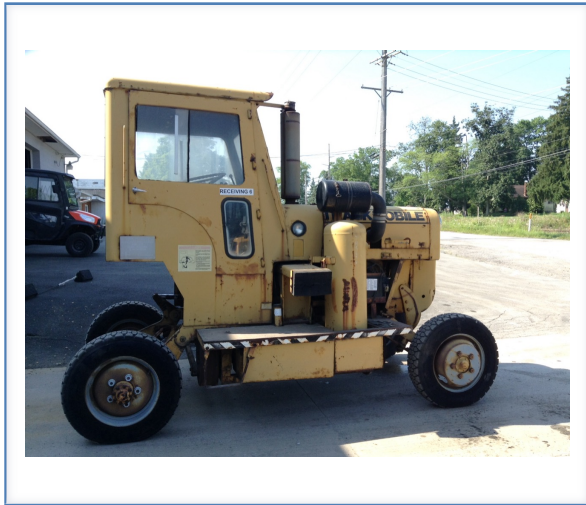
Capacity	
Tire Type	Pneumatic
Fuel	DIESEL
Drive Tire Size	8R 19.5
Steer Tire Size	8R 19.5
Attachments	
Key Included?	Yes
Weight	11000
Unit Operating?	Yes
Overall Rating	Fair
Overall Appearance	Fair
Engine Type	Detroit Diesel 5547-7040

Hydraulics Condition	Good
Drive Axle Condition	Good
Brakes Condition	Good
Parking Brake Condition	Good
Shift Action Condition	Good
Steer Axle Condition	Good
Sheet Metal Condition	Fair
Drive Tire Condition	Good
Drive Tire Tread	100%
Steer Tire Condition	Good
Steer Tire Tread	100%
Electrical System Condition	Needs Work
Seat Condition	Torn
Lights Condition	Good
Engine Condition	Good
Cooling System Condition	Good

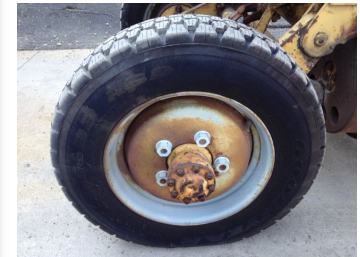
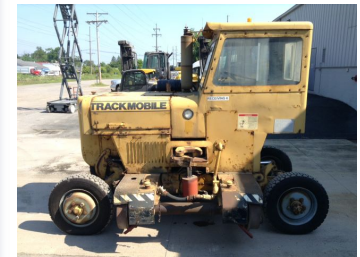
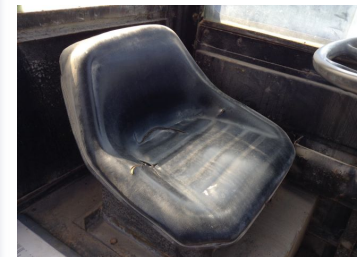
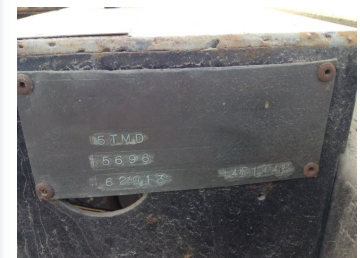
Front lift wheel cyl rusted/pitted: leaking.

Rear drive wheel carriage raise/lower hyd cyl chrome ram rusted/pitted; no seeping or leaks.

Oily res on and around final drive yoke flange.

Clunky noise in train wheel drive line; needs further diag and possible lube.

Lower hyd hose leaking on coupler raise lower hyd cylinder under L cab. Park brake can be driven through in fwd; rev OK.

Steer assys have some play in tie rods/bushings.

Damaged: Rad grill, metal front body cover, both metal str stop plates, L front & rear train wheel platforms dent/bent, R platform bent/dent, R rubber bumper worn/cracked, R air tank dent, hood dent/bent, R cab door mildly bent/dents, dash oil pressure gauge, front WS wiper blade worn, coupler release pull handle partially broken, hood cowl in front of WS rusted through, air box lid clamp/wing bolt & nut rusted, (1) broken screw front R upper king pin cover, lower front cowl insulation/sound mat, both front hood retainer clips, coupler height adj top chrome ram mild rust.
